ANSWERS TO QUESTIONS FROM COALCLIFF RESIDENTS REGARDING THE STORM ON APRIL 6, 2024

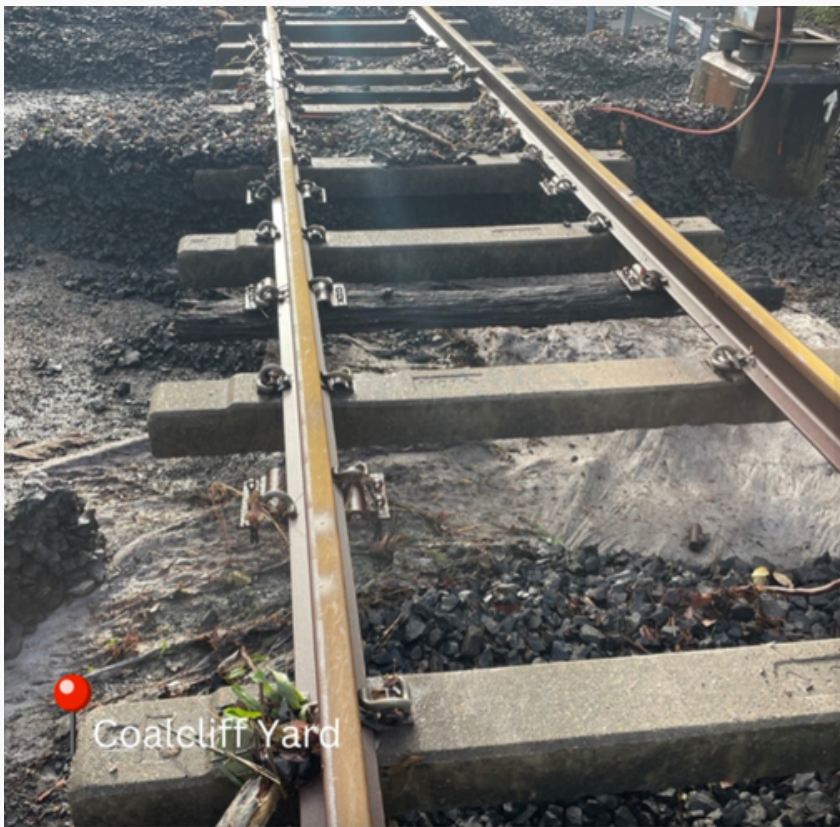
- Sometime during the storm, the flow in Stony Creek exceeded the capacity of the Sydney Trains rail culvert. This culvert ordinarily channels Stony Creek under the rail line. During the storm, water built up at the rail culvert entrance until it overflowed onto ICC's property. A very large volume of water then flowed north beside the rail tracks towards Coalcliff station before crossing the rail corridor directly above the location where it caused damage to Lawrence Hargrave Drive and deposited rocks and mud onto the road. The overflow of water from the rail line towards Lawrence Hargrave Drive caused massive erosion of ICC's property.

Below - Damage to the South Coast rail line at Coalcliff

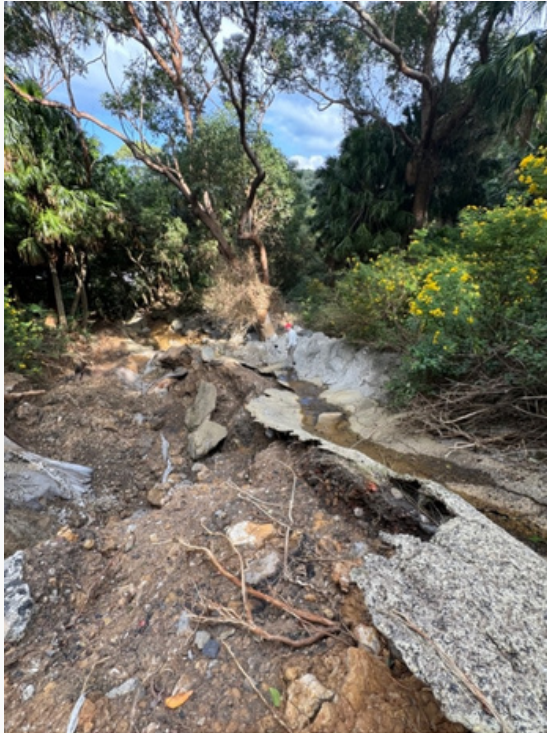
Below – Erosion on ICC’s property where the water from Stony Creek flowed after crossing the South Coast rail line at Coalcliff (note the figure in the centre of the photo)
